July 13, 2005

**RE: Next Media Operating, Inc.
Work Plan Implementation Update
114 Tower Hill Road
Gilberts, Illinois**

CONFIRMATORY / DELINEATION
SAMPLE LOCATION MAP
114 TOWER HILL ROAD
GILBERTS, ILLINOIS

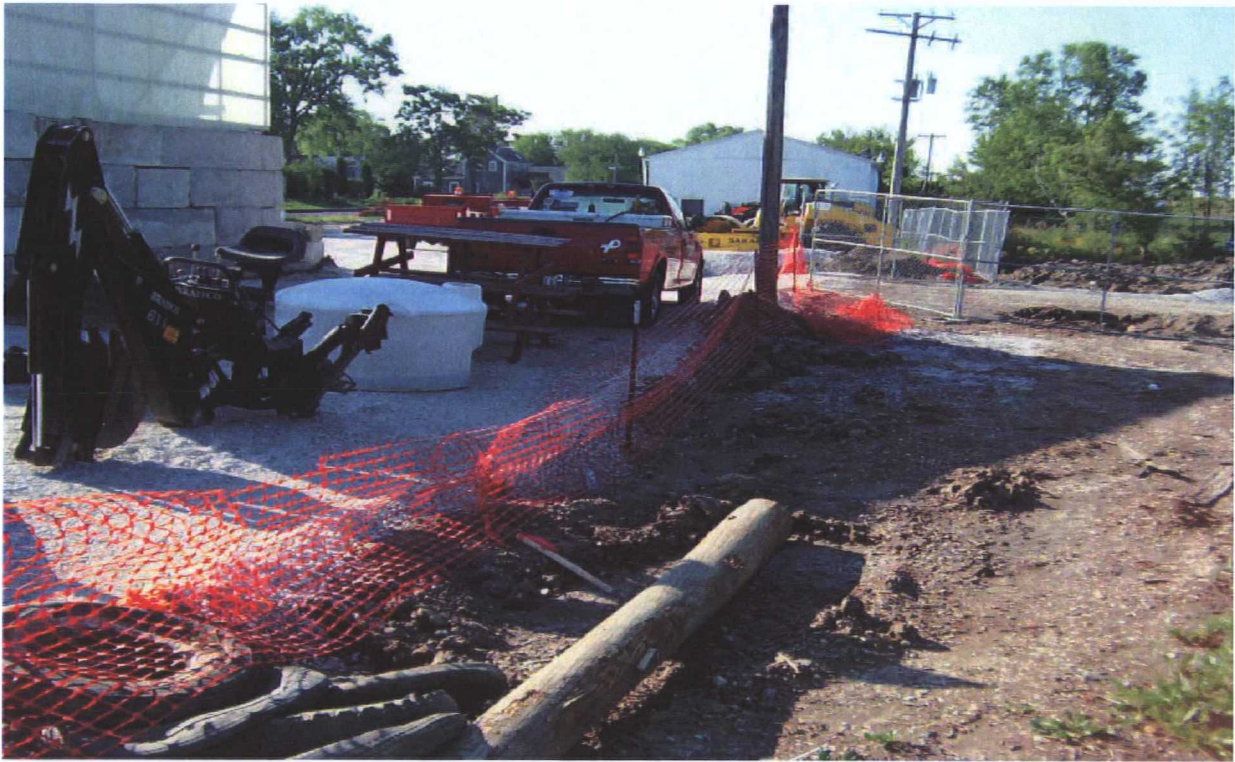
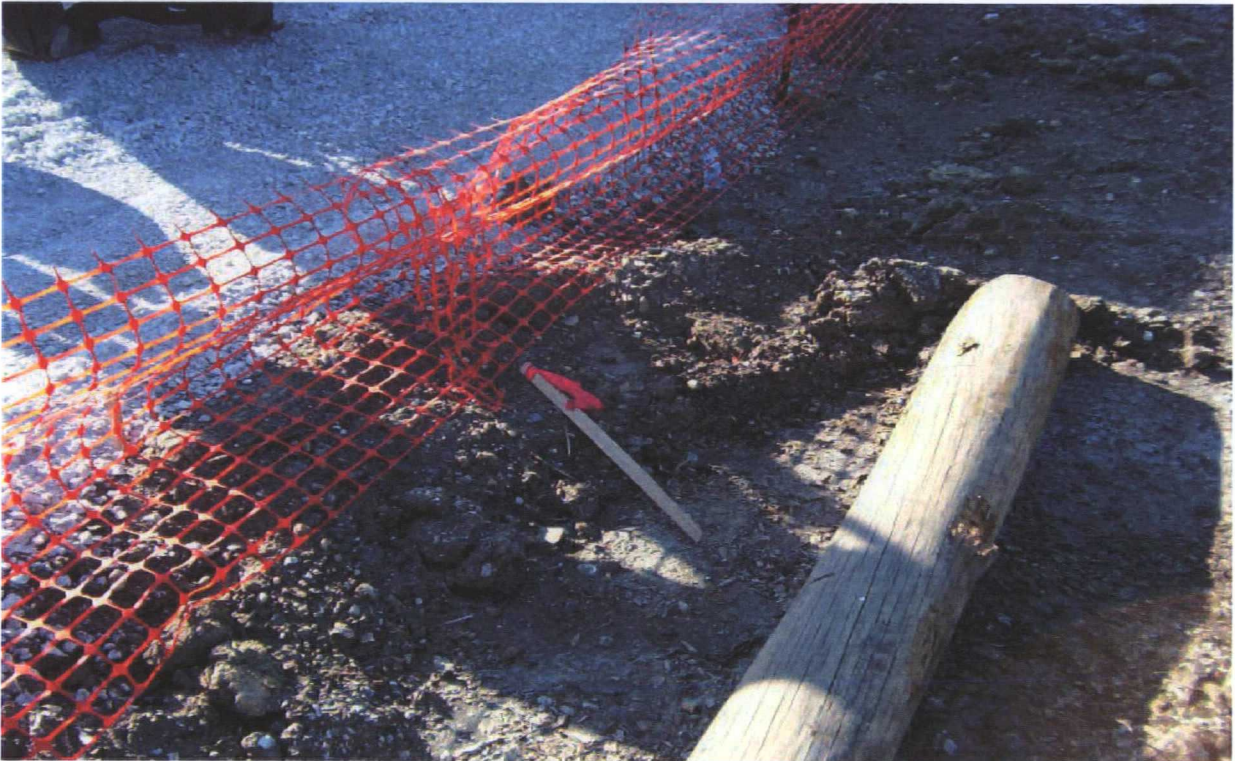
Photo 37/38 – View of damaged property boundary stakes on Site (facing south).

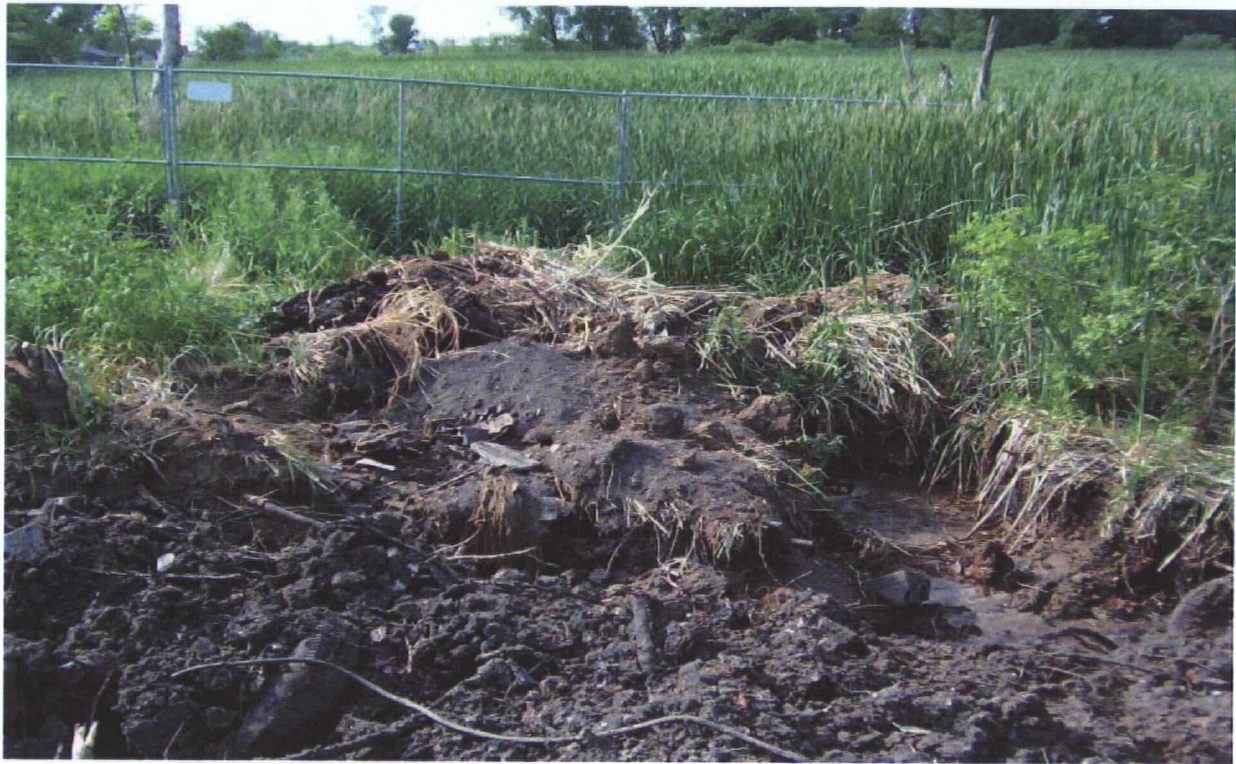
It should be noted that although URS obtained a clean delineation and side wall sample at WW-1 and WW-1CON, URS observed debris, including battery casings, near the southwest portion of the excavation. URS could not perform a full delineation of the debris and lead-impacted soils within this area due to the adjacent wetland to the immediate south and the nearby construction fencing. Based upon the current logistical issues associated with accessing this area, URS recommends that this portion of the Site be further investigated and remediated in conjunction with the South Wall phase of the project.

Photo 40 – View of additional west wall material to be treated in conjunction with south wall (facing south).

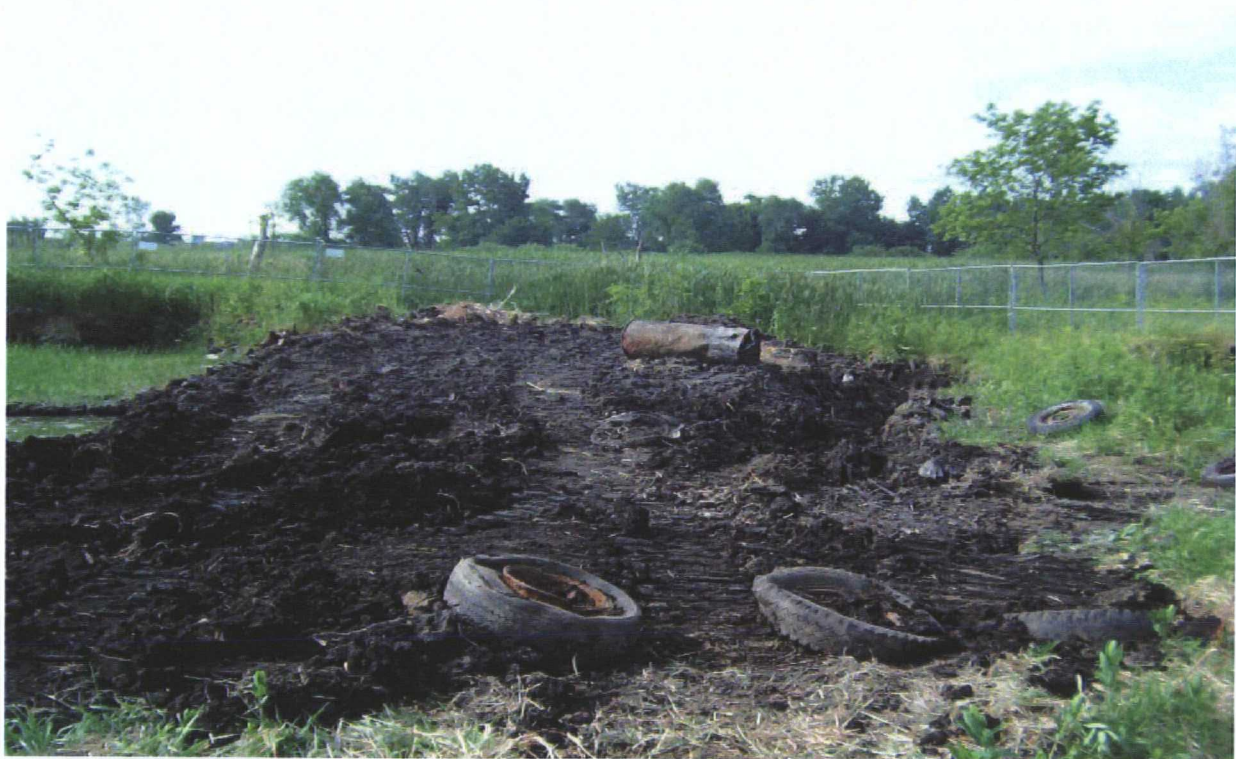
Photo 41 –View of treated material along west wall and unearthed saddle tank (facing south).

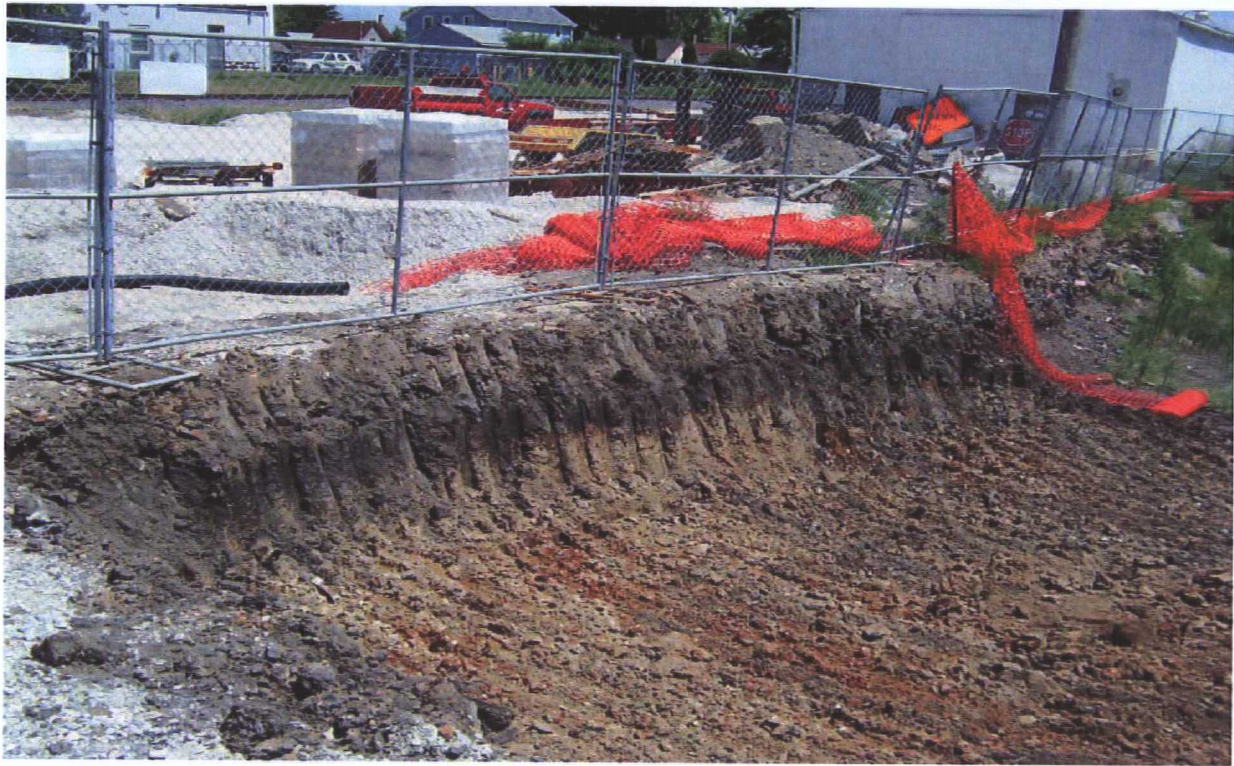
Photo 51 – View of excavation following removal of treated material along north excavation wall (facing southeast).

Removal of treated material occurred on July 7-8, 2005. RWC removed a total of 54 truckloads of treated material from the Site, which was transported to the Orchard Hills Landfill, a USEPA-approved disposal facility, in Davis Junction, Illinois (see Photos #51-53). URS will determine the tonnage of material removed and confirm receipt of the material by the landfill upon receipt of load tickets and disposal manifests from RWC. In addition, URS collected a total of twelve (12) confirmatory floor samples and four (4) additional confirmatory side wall samples from the excavation. The samples were submitted to STAT on July 8, 2005. URS anticipates receipt of these results during the week of July 18, 2005.

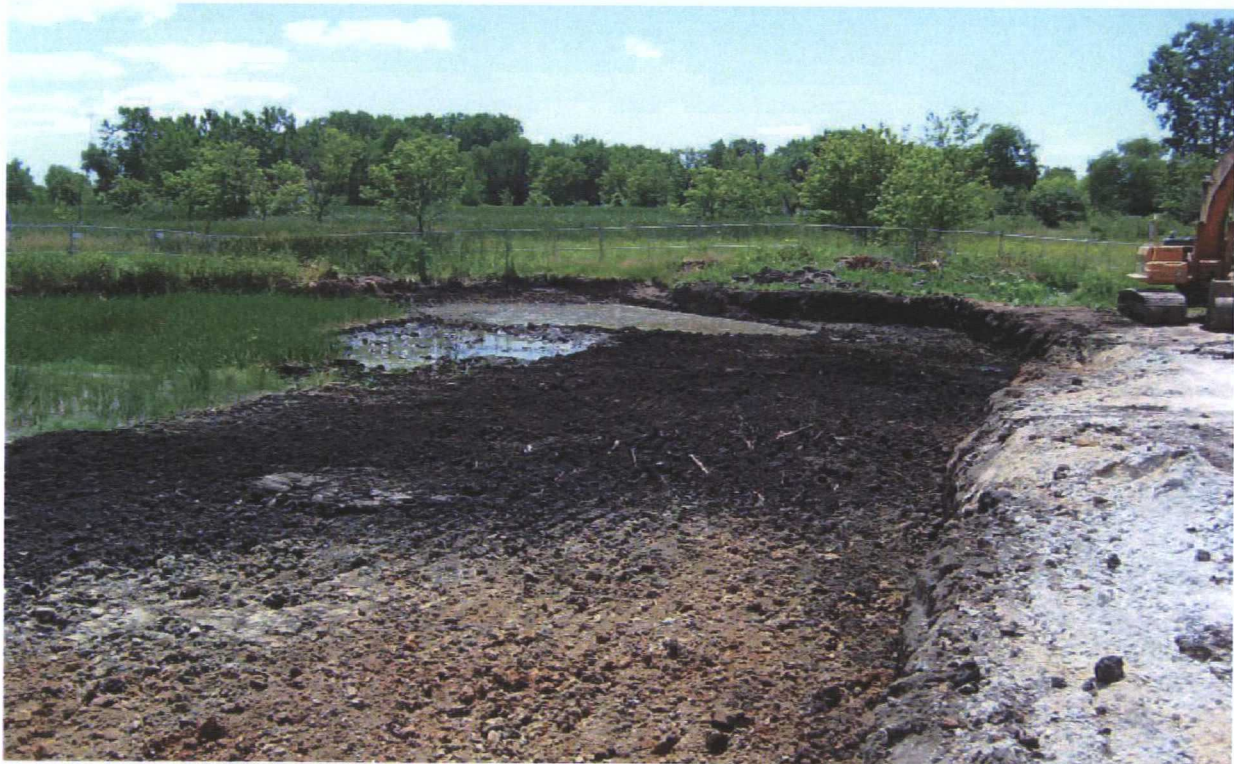
Photo 52 – View of excavation following removal of treated material along north excavation wall (facing west).
